Maciej KOTUŁA^{1,3}

RESEARCH OF WATER CONDENSATION IN GAS TRANSMISSION PIPELINES

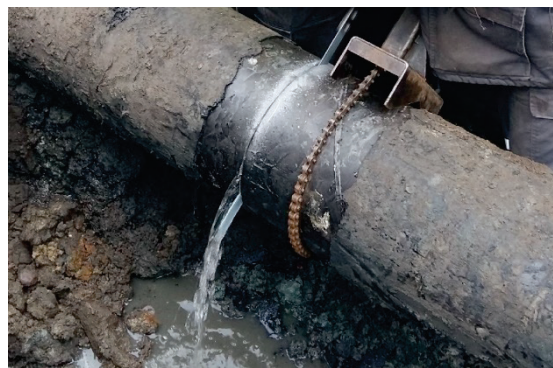
FIGURE 1. Cutting of the DN300 gas pipeline at Myśliwska Street in Kołobrzeg

Pressure measurements at the sampling points showed unacceptable values in the range of 0.65-0.82 kPa. At that time, the reduction stations supplied the gas at the right pressure with a large capacity reserve. This indicated that the main gas pipeline was no longer permeable. The network layout and the foundation ordinates, the pressure measurements, the lay as well as the type of land development and utilities were analysed. As a result of this analysis, the characteristic points on the gas network where the control excavations had to be made were selected. Measurements were made with the use of a double bag-positioning device. In this way, the search site narrowed to a section of about 15.0 m at the lowest point of the terrain.

After cutting of the pipe, water escaped from it instead of the gas and a pump was installed instead of the bag-positioning device. In total, about 500 litres of water were pumped out, which meant geometrically that a section of the gas pipeline of the length of almost 7.50 m was completely flooded with water. The sections flooded with water were also found in other areas of the network system (Fig. 1).

The analysis of the causes of the incident from the side of the gas plant was conducted only in one direction – the search for a potential place of leakage which would allow for penetration of such quantity of water into the gas pipeline from the outside. Such a place was not found until these gas pipelines were replaced with new polyethylene ones. Therefore, the thesis that water got into the gas pipeline through the places of leakage has never been proved unambiguously.

This is what happened in the case of the analysed failure in Kołobrzeg. At that time, the use of the dehydrators during construction of passages under the tracks was definitely required due to greater deepening with creation of a natural trap. However, this requirement was omitted during network modernisation.

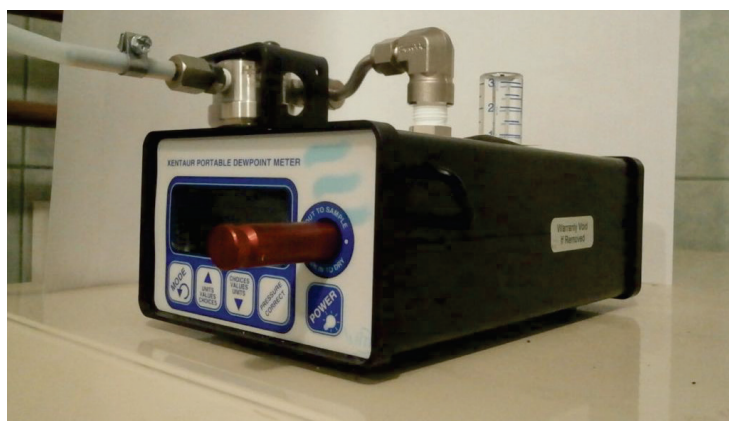
FIGURE 2. XENTAUR moisture meter, HPDM type

The measurements were carried out with the use of XENTAUR portable dew point analyser, HPDM type (Fig. 2). It is a microprocessor-controlled, battery-powered moisture meter, equipped with a dry chamber for storage of the sensor. This allows for obtaining of a reliable result after moving of the sensor to the measuring cuvette, ensuring the maximum possible tightness and the lowest possible gas exchange between two chambers during the sensor movement.

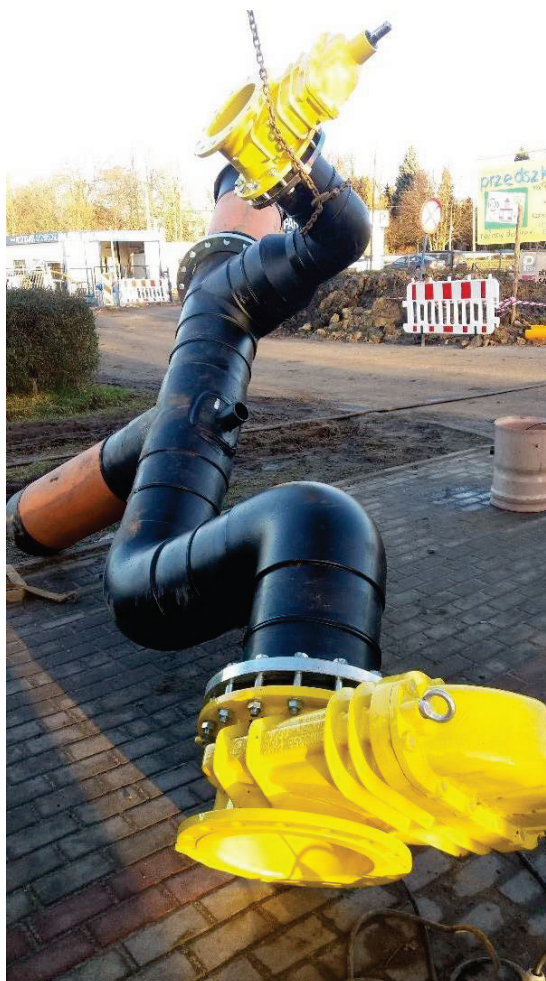
FIGURE 3. Polyethylene dehydrator with diameter DN 355 (without inspection pipe)

Appropriate conclusions were drawn only after the failure. Figure 3 shows the dehydration system prepared for installation during replacement of three sections of the gas pipelines running under the tracks with a new PE gas pipeline with the main diameter DN 355 mm upon the request of the network operator in Kołobrzeg.

2. The analysed failures prove that regardless of the source of water, it is unjustified to dispose of the dehydrators, especially in a mixed gas network made of polyethylene and steel pipes distributing the gas from the local wells of the L_w and L_s subgroups.
